MIKE GOODBUN'S DEFENDER 110

Editor Mike's 2012 110 Utility Wagon is gradually receiving upgrades to improve its usability and longevity, along with a few other choice modifications. This month it's having the troublesome gearbox extension shaft and drive cup replaced with uprated parts from Ashcroft Transmissions.

Fit uprated output shaft

Eliminate the weak link in your Defender's driveline with this Ashcroft kit

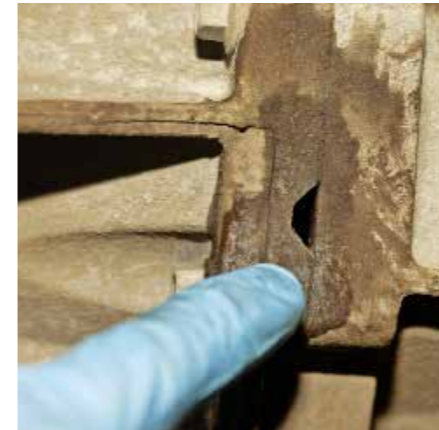
Seeing red?

1 This hole between the main gearbox casing and the extension housing can be a good indicator if wear is present. Any red dust or staining could point to a worn drive coupling. Excessive driveline slop when driving is also a symptom of wear, so check periodically.

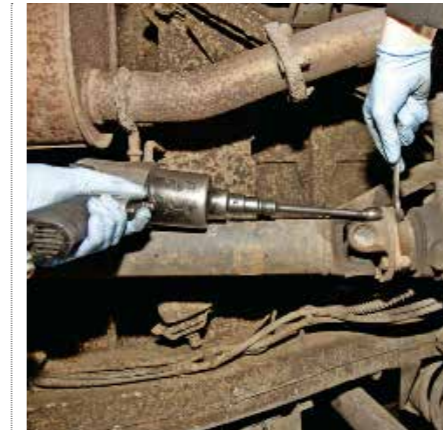
Remove propshafts

2 Sid uses an air gun with special propshaft bolt attachment and 3/8in spanner to loosen all the fixings. Take care not to let the propshaft ends drop from the diff flanges, as this could damage the universal joints. Lift the shafts away and place aside.

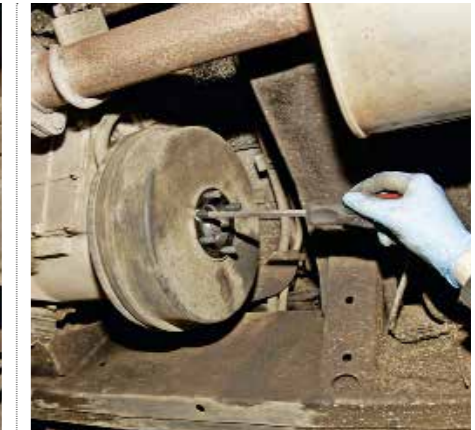
Remove handbrake drum

3 With the props out of the way, undo the Phillips screw securing the handbrake drum; use an impact driver if the screw is very tight. Remove the drum, ensuring the handbrake is released first! You may need to back off the adjuster if it's stubborn to come off.

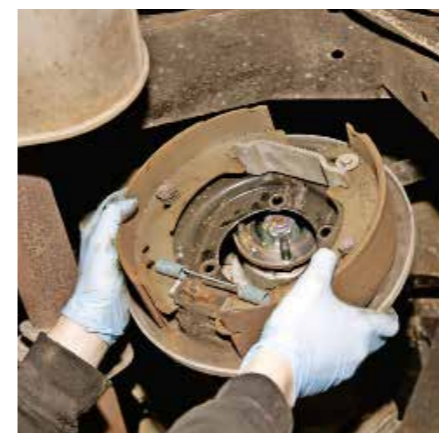
Unbolt the mechanism

4 The handbrake mechanism is secured to the back of the transfer box with four 15mm bolts. Undo the bolts and manoeuvre the assembly away. To avoid messing with the cable, Sid uses a bungee cord to hold the handbrake safely out of harm's way.

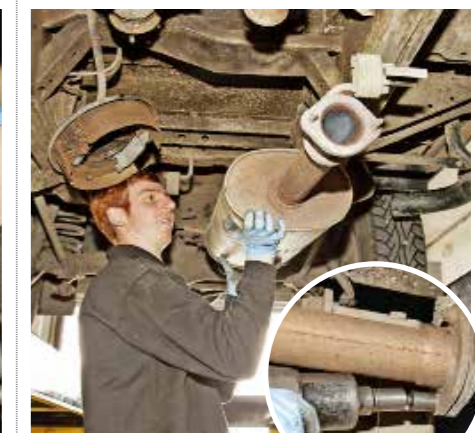
Reposition exhaust

6 Undo the nuts securing the exhaust centre section to the downpipe; two mounts must be released. The rearmost rubber can be shifted with a lever bar; the front one can be unbolted from the chassis. Push the exhaust to one side and secure with wire or a bungee.

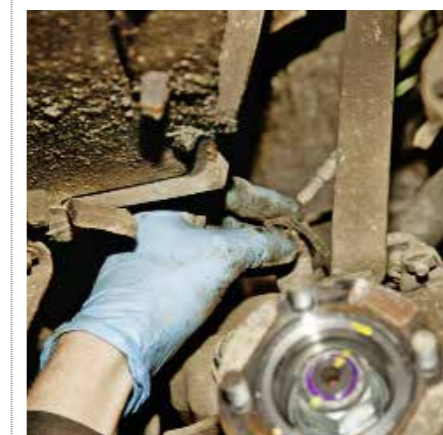
Connectors and breather

8 In the same area, release the two electrical connectors from the bracket and unplug them; they can be fiddly. Use a 14mm socket to undo the transfer box breather pipe, taking care not to lose the copper sealing washers from the banjo bolt.

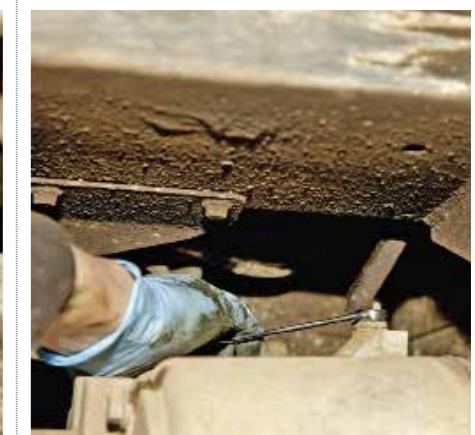
Unbolt earth straps

9 There are two earth strap locations on the LT230. One is on a stud on the nearside of the box, attached to one of the fixing bolts. The smaller one (which is easy to forget!) is above the offside gearbox mount. Undo the 10mm bolt and tuck the wiring aside. **12**

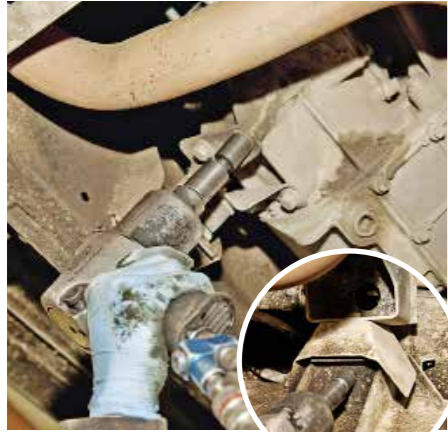
Release mountings

10 Undo the four 15mm bolts securing the bracket to the transfer box. Remove the nut on the nearside mount's stud; don't unbolt the bracket as it's attached to the gearbox rather than the transfer box. This allows enough movement for the assembly to be jacked up.

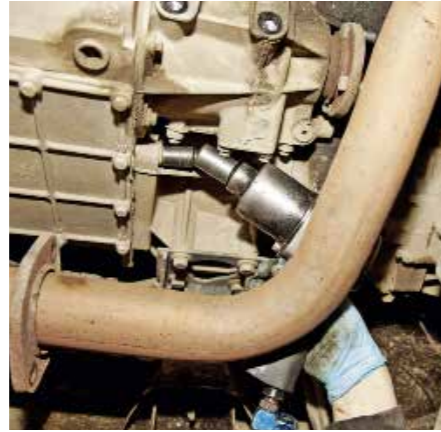
Unbolt from gearbox

11 Now separate the transfer box from the gearbox. Note which bolt comes from where, as they're different lengths. There are four bolts and two nuts; four fixings run from the back of the transfer box to the front, and the other two from the front to the back.

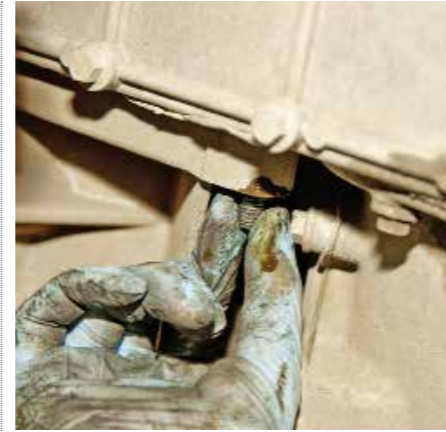
Prevent leakage

12 Sid shows me a handy trick. One of the bolts goes into the main chamber of the LT230, so oil leaks out when removed. By replacing the bolt with a stud, the hole is plugged while still allowing the box to be removed. This saves the mess of draining and refilling.

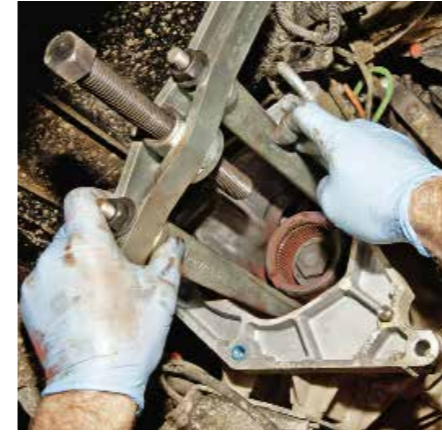
Pulling power

19 The cup is an interference fit on the gearbox mainshaft, so will need removing with a puller. Loosely refit the centre bolt to give the puller something to act on, then wind the cup off the gearbox mainshaft. Wind the bolt out again and withdraw the cup.

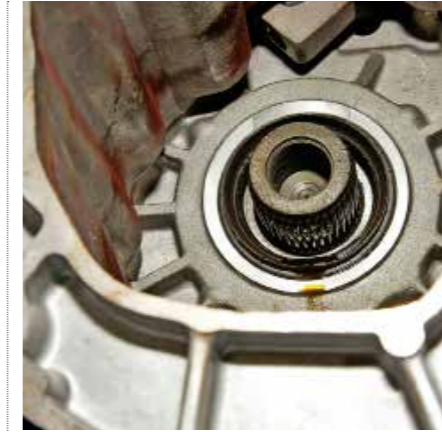
Clean the area

20 Give the inside of the extension housing a good wipe-down with a rag and some brake cleaner. Any debris left inside could contaminate the shafts and reappear at the tell-tale hole, giving the impression wear is still present despite the modified parts being fitted.

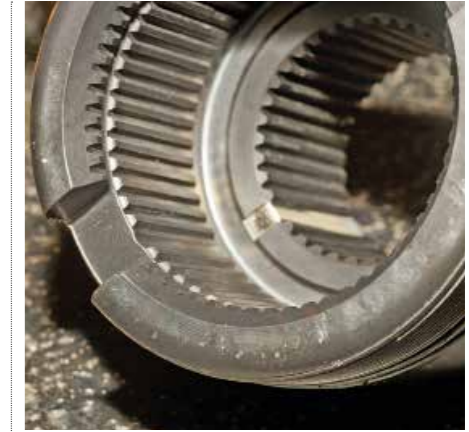
New drive cup

21 Here the difference between old and new lies. Slots spark-eroded into the splined portion of the cup allow oil to 'leak' from the main gearbox into the coupling, providing lubrication. The oil is then contained by two O-rings inside the housing.

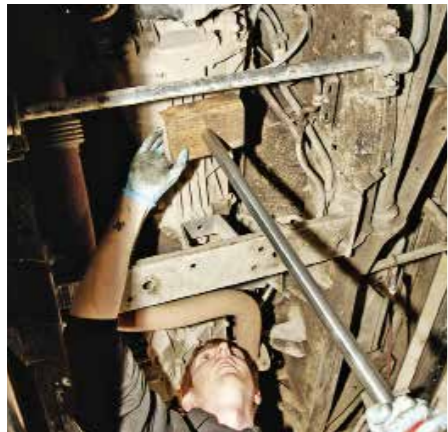
Jack-of-all-trades

13 The transfer box won't come off without some persuasion, as the gearbox shaft and its studs hold it. A pillar jack and block of wood is used to raise the boxes off their mounts. Don't jack it up too far, though – just enough for the transfer box to clear.

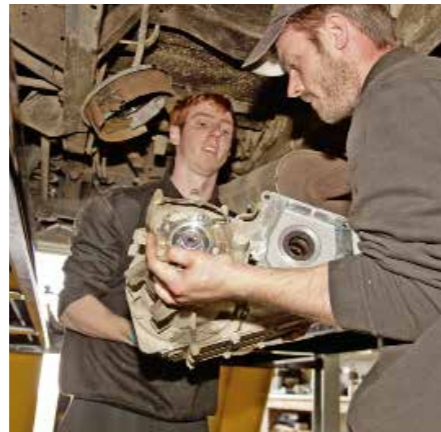
Remove transfer box

14 With the help of an assistant or another jack, slide the transfer box off the gearbox and lower it to the ground. It may need a lever with a bar or strong screwdriver to get going, so make sure you're ready to support it once it's been worked free.

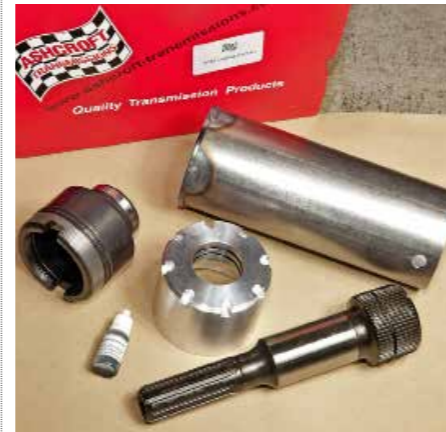
What's in the box?

15 The comprehensive Ashcroft kit includes a new drive cup with drilled oil channels and threaded outer, new extension shaft and custom oil housing. It also includes a special tool to wind the housing into place and a bottle of threadlock to install the parts.

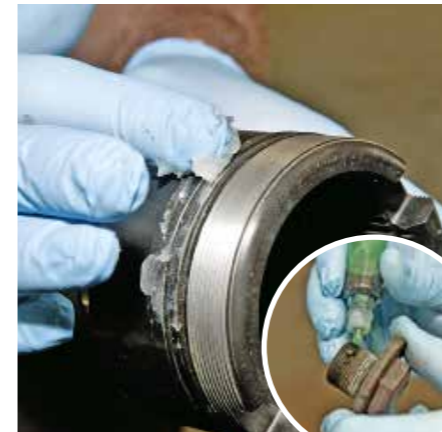
Prepare for installation

22 Apply a smear of rubber grease to the O-rings, to prevent them pinching when everything goes together. Clean any old threadlock off the drive cup bolt, then apply a bead of new compound from the supplied bottle.

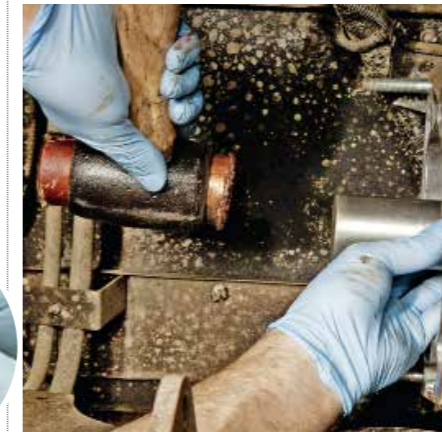
Fit the modified cup

23 Apply some clean oil to the splines and then, using a suitable drift, gradually knock the new drive cup into place. Make sure the cup is set on to the shaft the same distance as the original, then fit the threadlocked bolt. Torque it to 133lb ft.

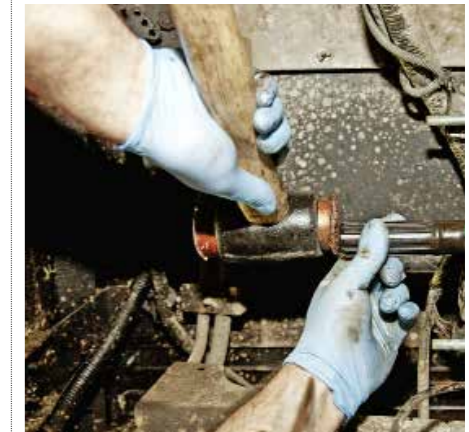
Fit new output shaft

24 Ensure the spring clip is fitted correctly and central on the shaft, then oil the splines. Line up the new extension shaft and tap it into the new drive cup with a soft-faced hammer until fully home. Tug it to make sure the spring clip has locked into place properly.

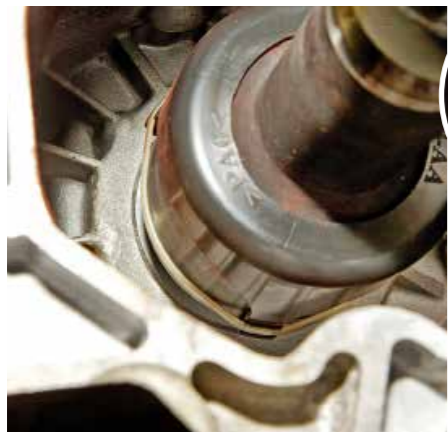
Cut all ties

16 The first thing you are presented with in the gearbox extension housing is a black dust cover, held in place with a white cable tie. Snip the cable tie with a pair of side cutters and slide the dust cover off, then throw it away.

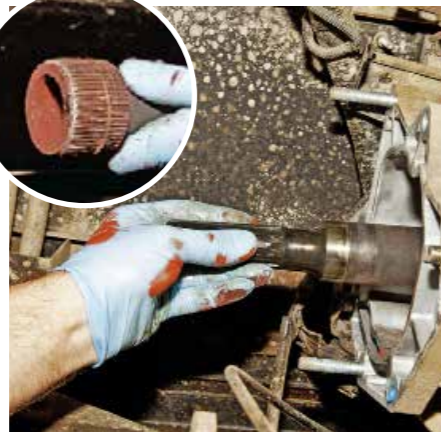
Remove extension shaft

17 The gearbox extension shaft is held into the cup with a spring clip, so a good pull should free it. When removed you can tell how worn the splines are. Ours weren't too bad, but the amount of red dust and corrosion shows they were starting to wear.

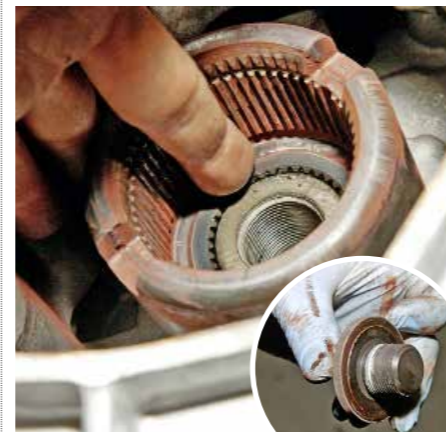
Unbolt drive cup

18 Undo the large bolt securing the drive cup to the gearbox. Once that's out, take note of the distance between the inner face of the cup and the end of the shaft it sits over; the new cup must sit the same depth when installed.

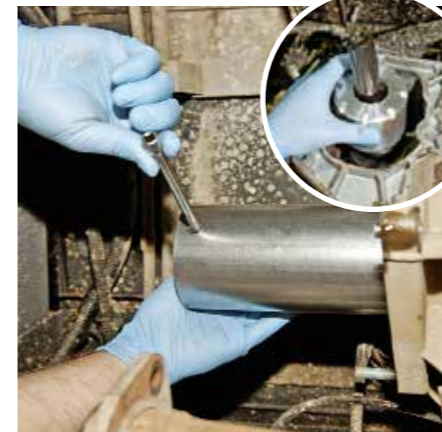
Install the housing

25 With the seals lubricated and threadlock applied, the housing can be slid over the extension shaft and wound on to the threads of the new drive cup. The housing must then be tightened using the special tool; Gary uses a long extension bar to apply extra leverage.

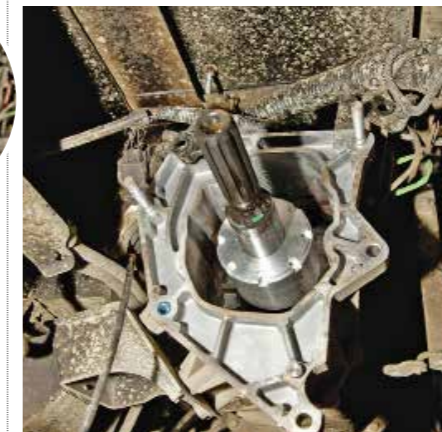
The finished article

26 Oil gets into the aluminium housing from the gearbox via slots in the splined parts of the drive cup and extension shaft. The housing seals over the shaft and prevents gearbox oil spraying out as the vehicle is driven, while keeping the splines wet.

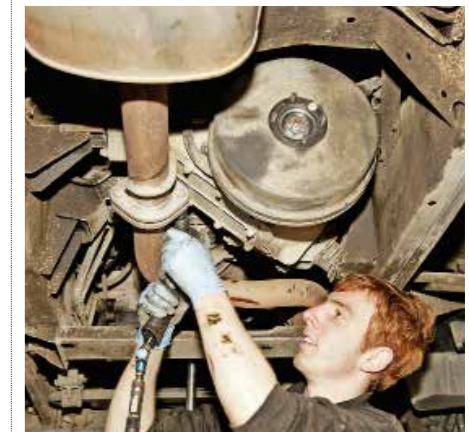
Rebuild and test

27 All that's left is to refit the transfer box, props and exhaust and go for a drive. Even though the splines in Mike's 110 were only starting to wear, driveline slop is much reduced and the peace of mind from having fixed it early on is worth the money. **LRO**
